# Pavement Evaluation Report

Victoria Ponds Pavement Assessment  
Victoria Ponds Townhome Community  
St. Louis Park, Minnesota

Project B1903959

June 14, 2019

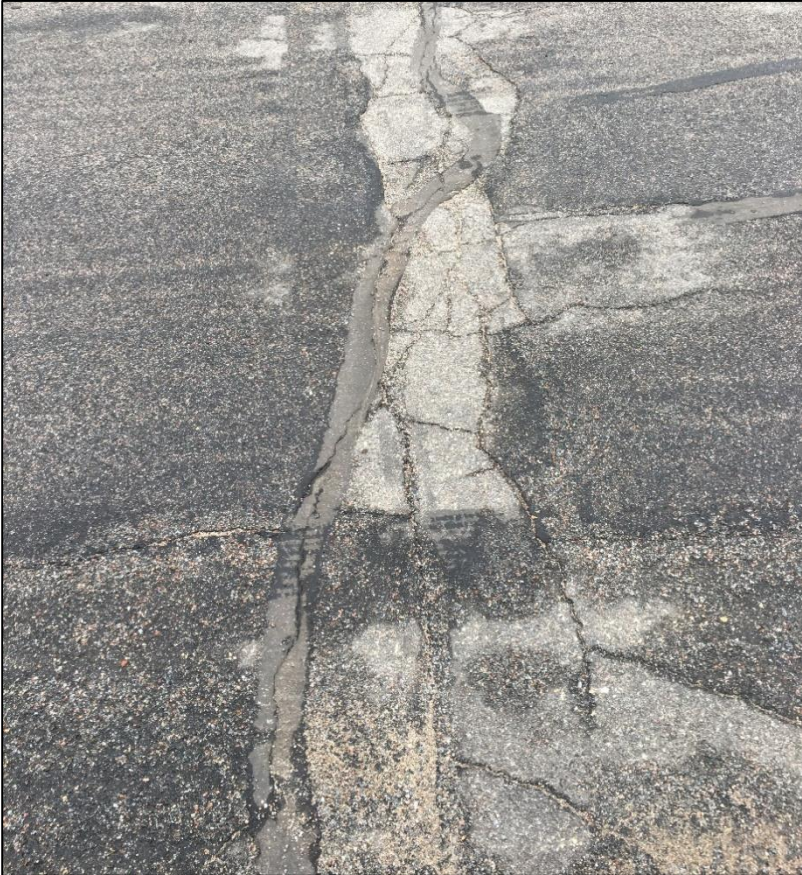
The street surfaces received a PASER rating of 4, having frequent low to high severity transverse and longitudinal cracks and edge cracks, with some of the cracks sealed. There were localized areas of alligator cracking ranging from moderate to high severity throughout the community. Surface treatment delamination is also present throughout, especially near cracks. Based on conversations with Mr. Fellman, the streets were chip-sealed about 11 years ago. Patching was also common, with several larger patched areas. Mr. Fellman and Mr. Bentley said the larger patches were done 2018, and were performed at the full pavement depth (about 3 to 4 inches) where severe alligator cracking and potholes were present. The figures below show the noted distresses.

**Photo 1. High Severity Transverse Crack Previously Sealed, Victoria Way**

It is therefore our opinion that the pavements would benefit from full-depth bituminous removal. Full-depth bituminous removal will allow for regrading and compacting of the existing aggregate base while maintaining grade with the existing curb and structures. It will also eliminate the reflective cracking associated with a partial-depth mill and overlay, which will reduce the need for maintenance over the short term and provide a more attractive, smoother top surface for a longer period of time.

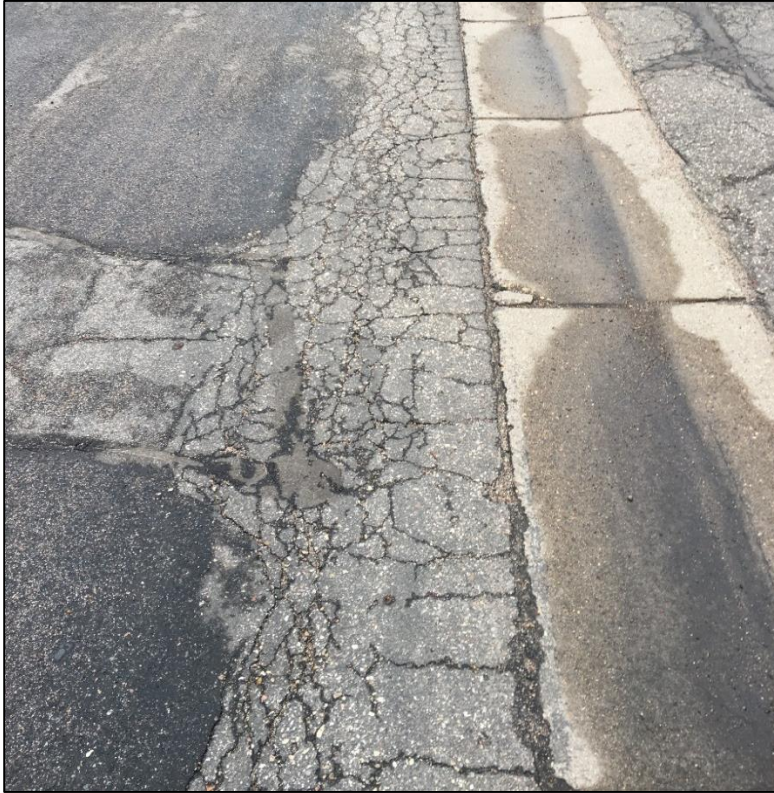
**Photo 2. High Severity Edge Cracking, Victoria Curve**

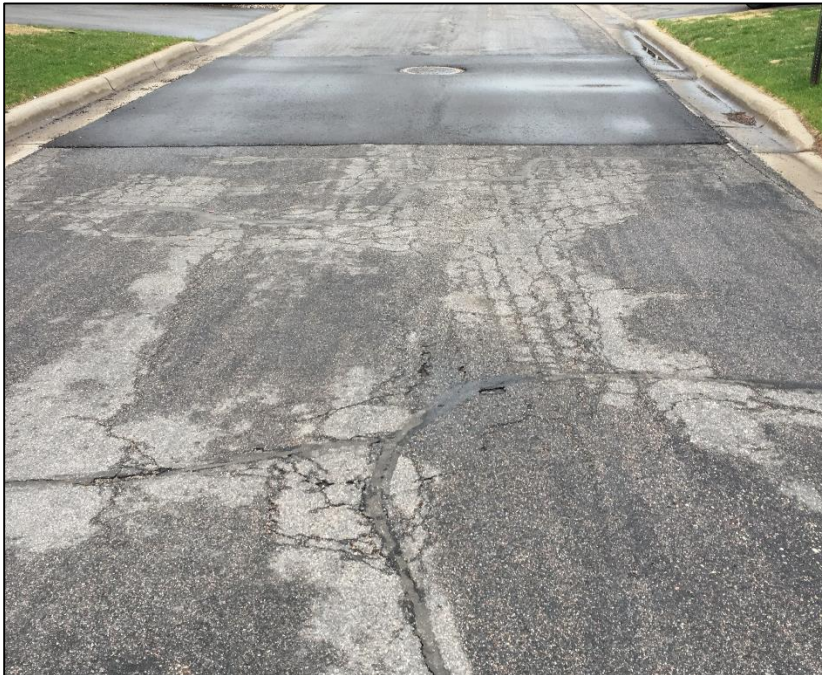
**Photo 3. Moderate Severity Alligator Cracking and Large Patch, Southeast end of Victoria Curve**

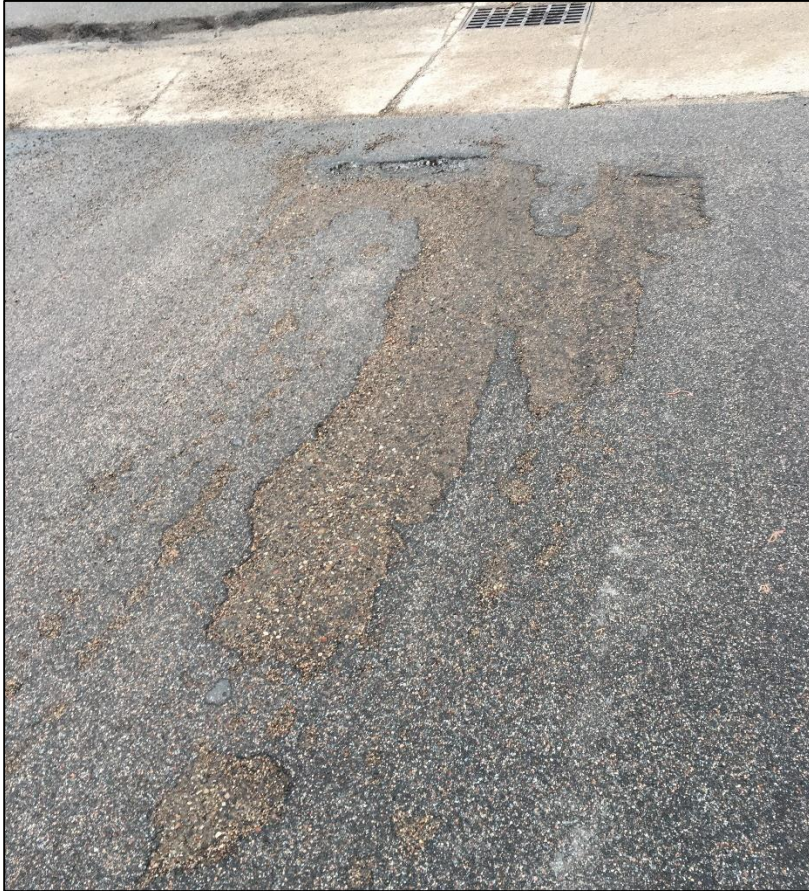
**Photo 4. Chip Seal and Surface Delamination, East Entrance to Community**

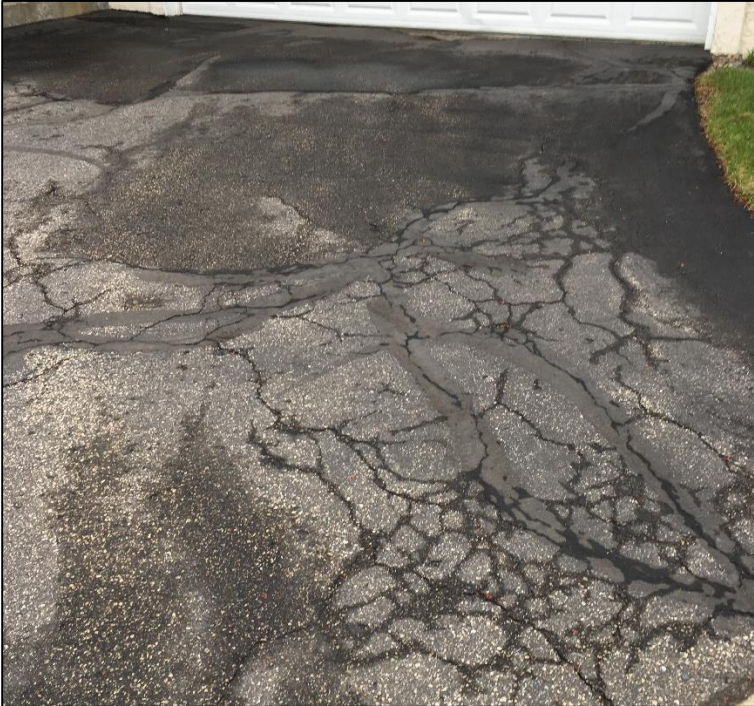
The driveways received a PASER rating of 4, having frequent low to moderate severity linear cracks, some developing into alligator cracking, and patching. Patching is especially common near concrete garage slabs and around utilities. Most driveways have settled and are no longer level with the concrete garage slabs and concrete curb. It appears some residents have had their driveways patched to level driveways with the adjacent garage slabs.

**Photo 5. Linear and Alligator Cracks**

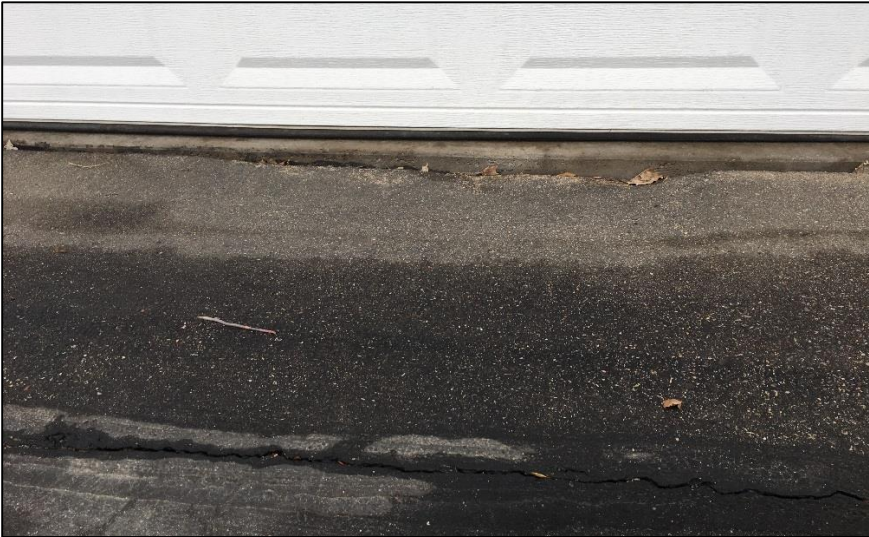
**Photo 6. Settlement near Garage Slab**

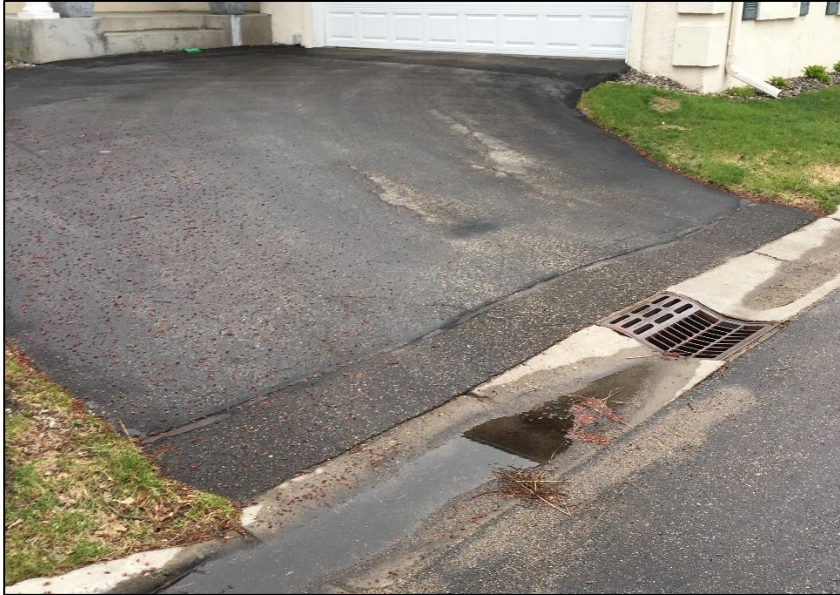
**Photo 7. Patching at Curb Line and Garage Slab**

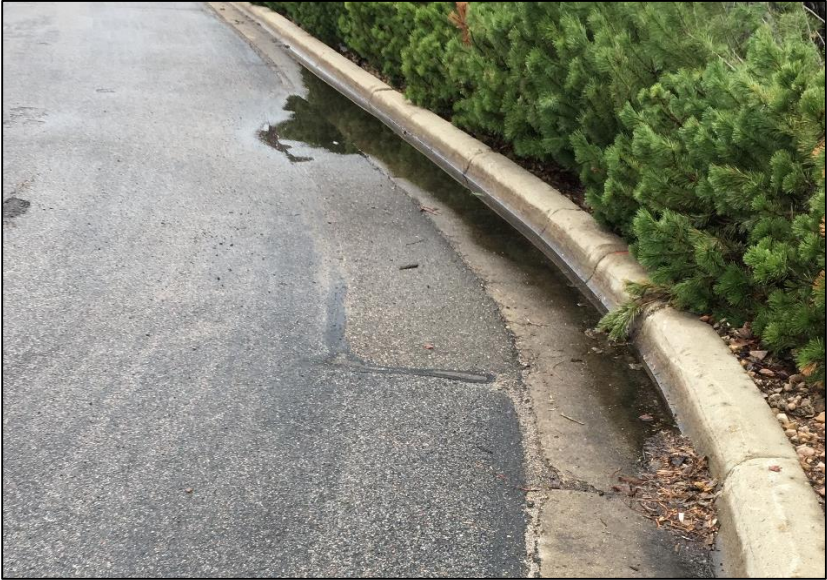
Some sections of curb are cracked and broken and some areas have settled, resulting in low points and ponding water. Although not common, some sections have faulted. Faulting was typically noted near storm drains and utilities. Most of the exterior perimeter curb was in generally good condition. The interior curb adjacent to the homes and especially at driveways, has more frequent distress and damage.

**Photo 8. Settled Curb with Ponding Water**

In our opinion, panels exhibiting cracking or settlement should be removed and replaced for spot repair. Photos 9 and 10 above show examples of a cracked panel; Photo 8 shows settlement distress.

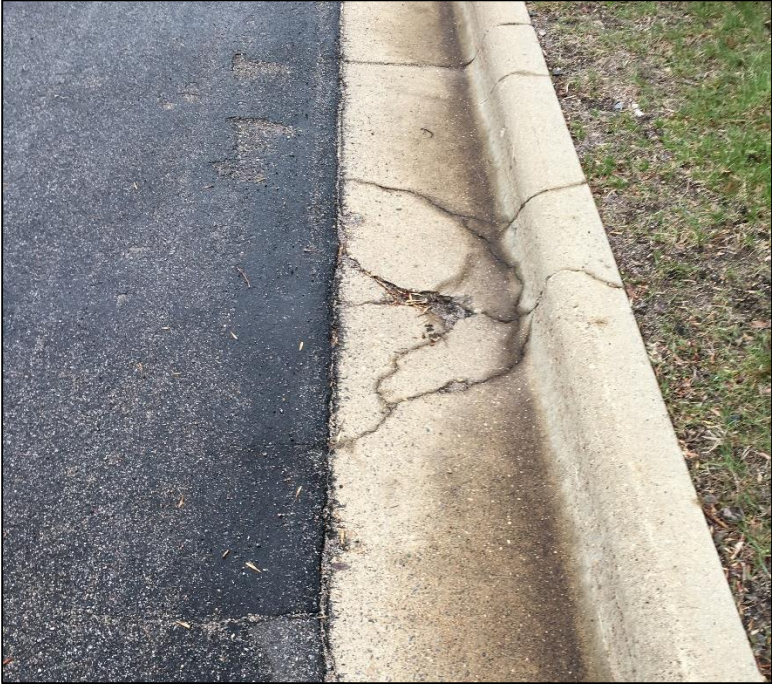
**Photo 9. Cracked Exterior Curb**

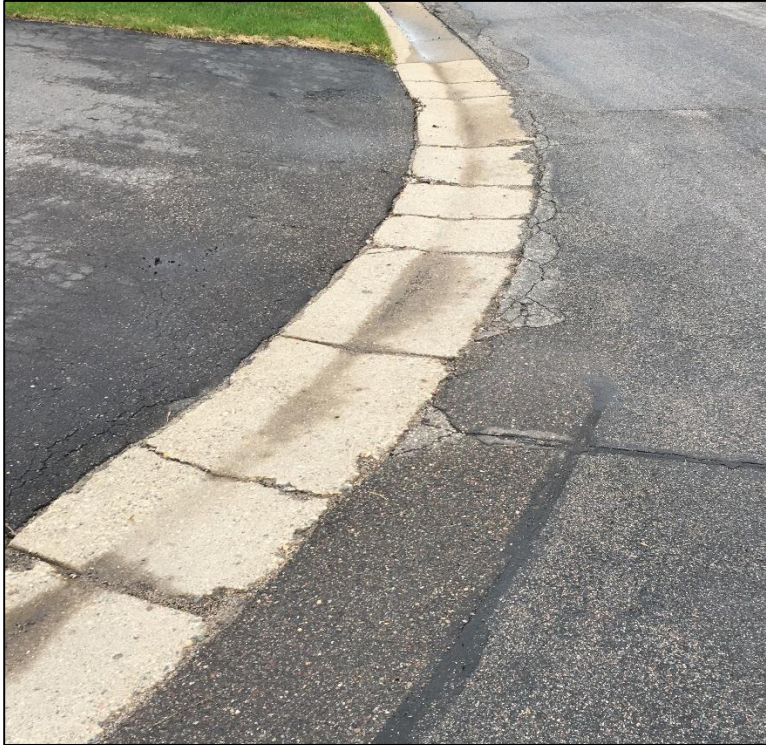
**Photo 10. Cracked Interior Curb at Driveway**
